Downstream spatial and temporal response to dam removal, White Salmon River, WA

DOWNSTREAM SPATIAL AND TEMPORAL RESPONSE TO DAM REMOVAL,

WHITE SALMON RIVER, WA

Thesis

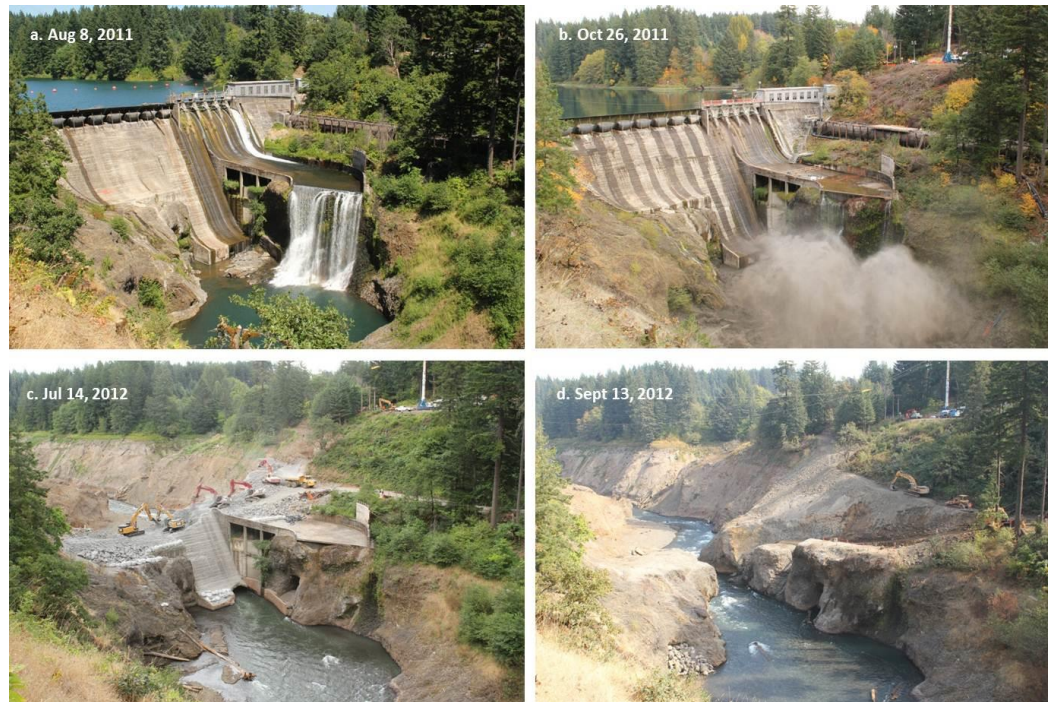
Figure 2: Time-lapse photography taken on river right hillslope about 100 m downstream from dam site: a. A typical pre-breach condition; b. explosive dam breach, ~50 seconds after the explosives detonation that breached the dam; c. progressive removal of dam structure, 8.5 months after the breach; d. dam site after the removal, 10.5 months after the breach (photos courtesy of S. Stampfli and A. Maser).

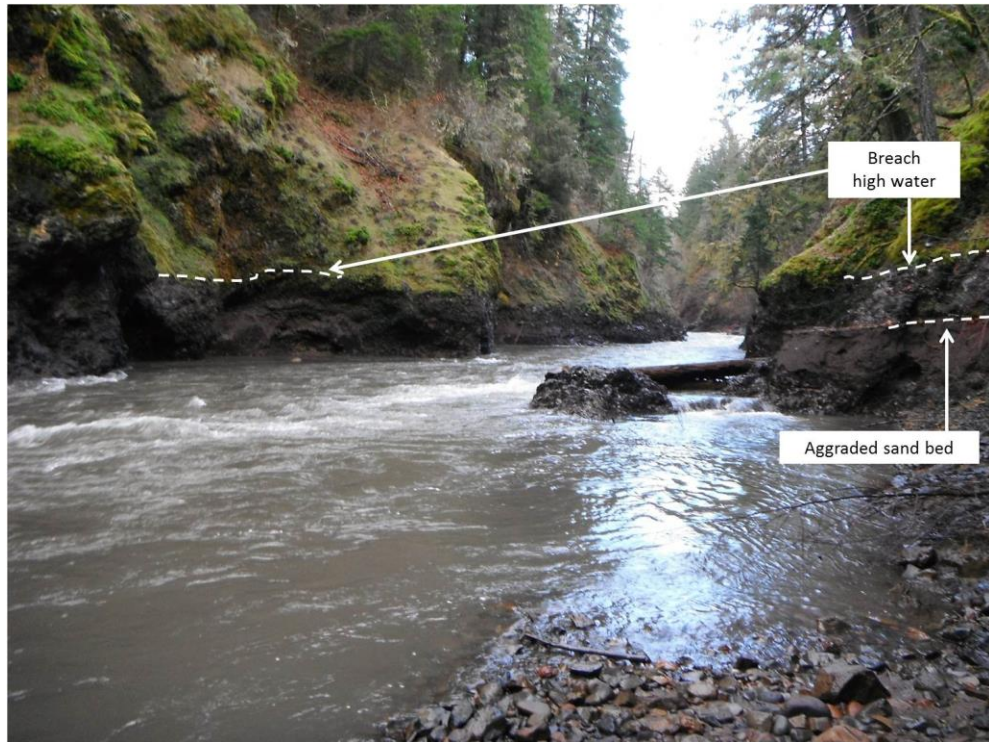
Figure 5: Breach high water mark and lateral sand deposits (aggraded sand bed) at 600 m downstream of dam, river left, looking upstream (January 8, 2012 photograph, ~2.5 months after the breach). The maximum breach flow covered the lower portion of canyon walls downstream of the dam with a silty film and the sand bed deposited within the 3 weeks after the breach left a terrace along the banks after subsequent bed incision

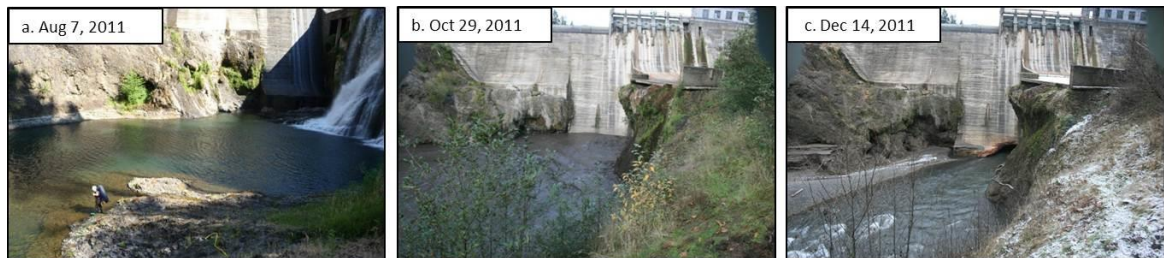
Figure 6: Photographs illustrating changes in morphology and water surface elevations, indicative of post-breach sediment deposition, at Condit Dam site from river right. a) pre-breach conditions at the dam site, b) conditions at the time of maximum bed aggradation, and c) conditions after bed had incised from its maximum aggraded level.

At the dam, time-lapse photography indicates maximum bed aggradation occurred on October 29, 2011, three days after the breach, as inferred from changes in water levels against the face of the dam during times of steady discharge (Figure 6b). At the USGS gage 2,350 m downstream, analysis of stage indicates that the bed reached its maximum level of aggradation of 1.1 m above pre-breach conditions on November 7, 2011, 12 days post-breach (Figure 7). Photo analysis near the river mouth, 5,200 m downstream, reveals that the maximum sand bed aggradation occurred on November 13, 2011, 6 days after the maximum aggradation at the gage and 18 days after the breach. Dividing the downstream channel distance traveled by time yields a downstream travel rate for the zone of maximum aggradation of 196 m day^{-1} between the dam site and gage, 475 m day^{-1} between the gage and 5,200 m downstream of the dam (Figure 8b), and 289 m day^{-1} from the dam to the mouth.

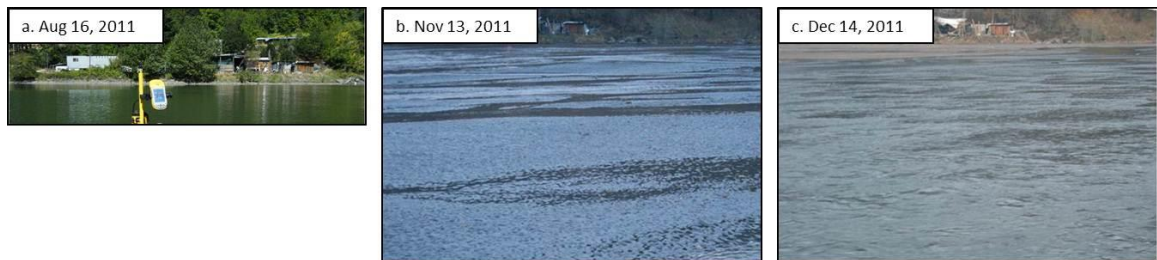
Figure 8: Photographs illustrating changes in morphology and water surface elevations, indicative of post-breach sediment deposition, in reach 2, 5,200 m downstream from dam. a) pre-breach conditions at the mouth, b) conditions at the time of maximum bed aggradation, and c) conditions after bed had incised from maximum aggraded level.

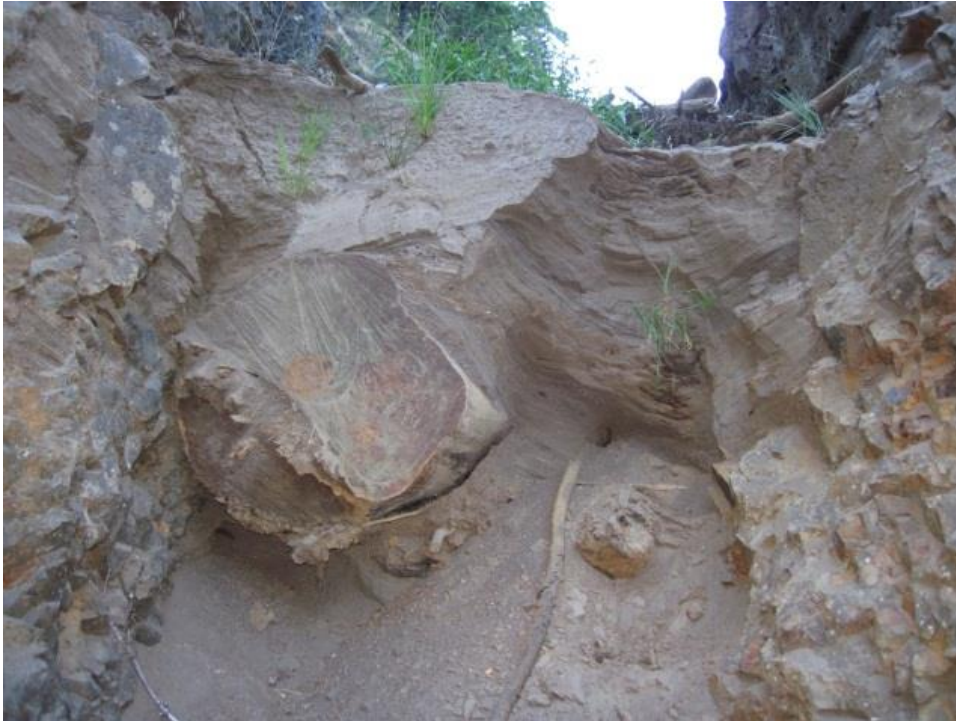
100 m downstream of dam, river right, looking downstream at close-up view of aggraded sand bed terrace deposit (Aug 2, 2012 photograph)

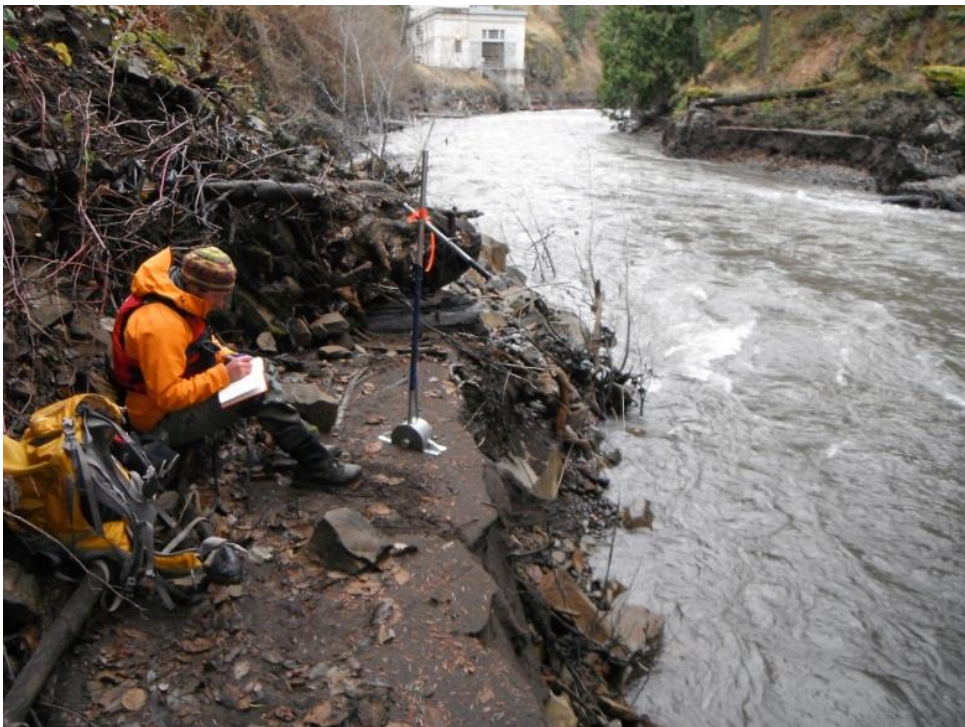
1,900 m downstream, river left, looking downstream at powerhouse. Terrace visible on both left and right banks. (Jan 2012 photograph)

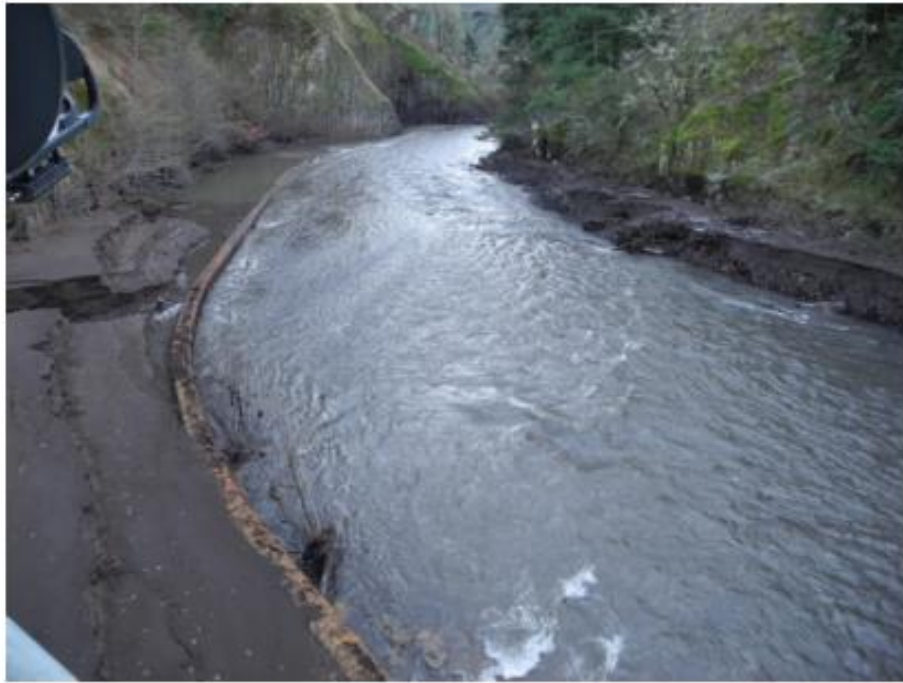
2,000 m downstream, river left, looking downstream from powerhouse. Terrace of aggraded sand bed seen on both left and right banks. (Dec 7, 2011 photograph from PacifiCorp Energy (2012))

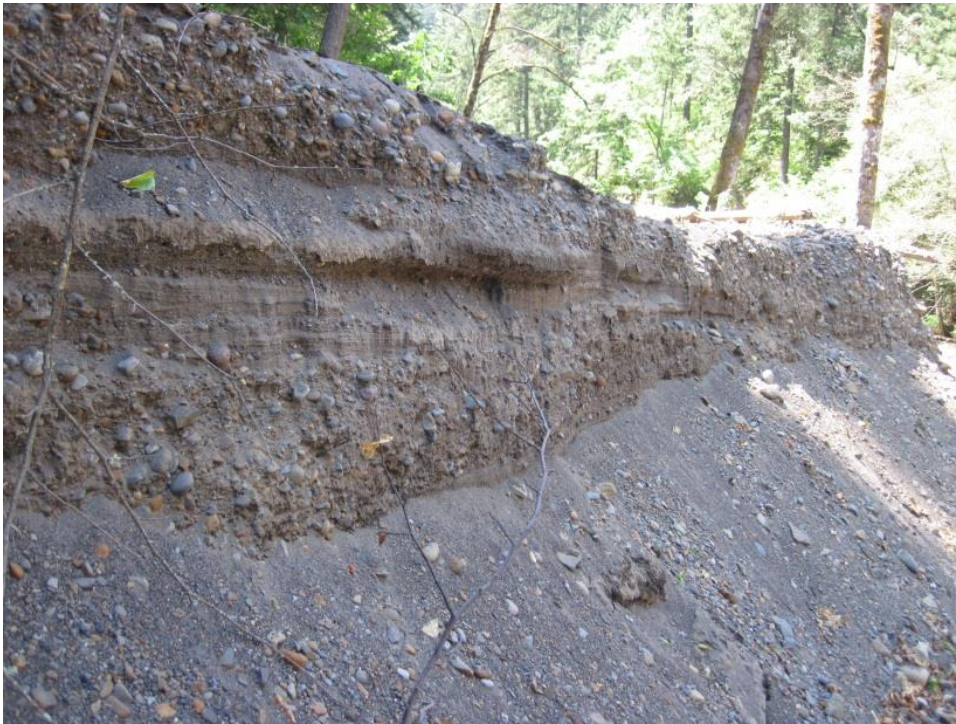
3,100 m downstream, river left, angled downstream showing vertical face of terrace (Aug 2012 photograph)

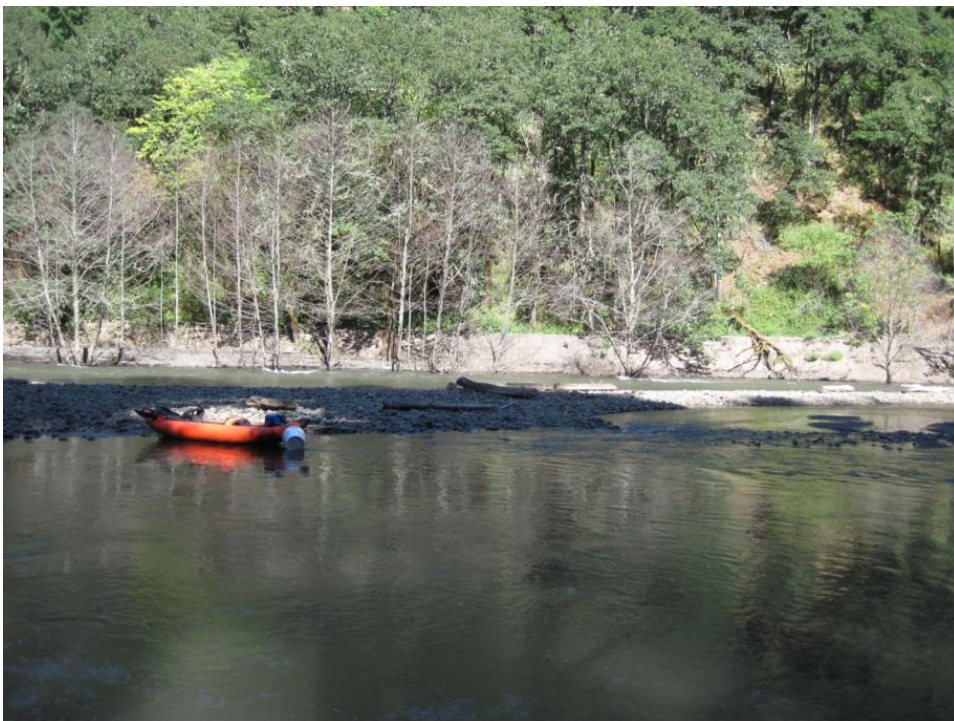
3,700 m downstream, river right, looking at left bank. Sand bed terrace visible as horizontal, gray deposit above channel (Aug 14, 2012)

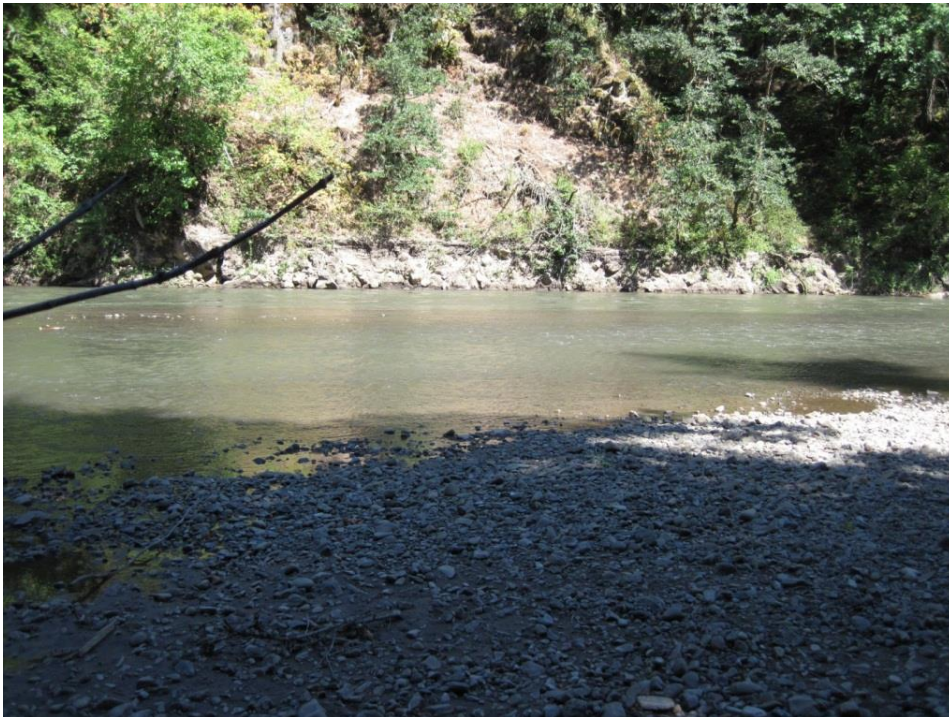
3,900 m downstream, river right, looking at left bank. Sand bed terrace visible as horizontal, gray deposit.
(Aug 14, 2012 photograph)

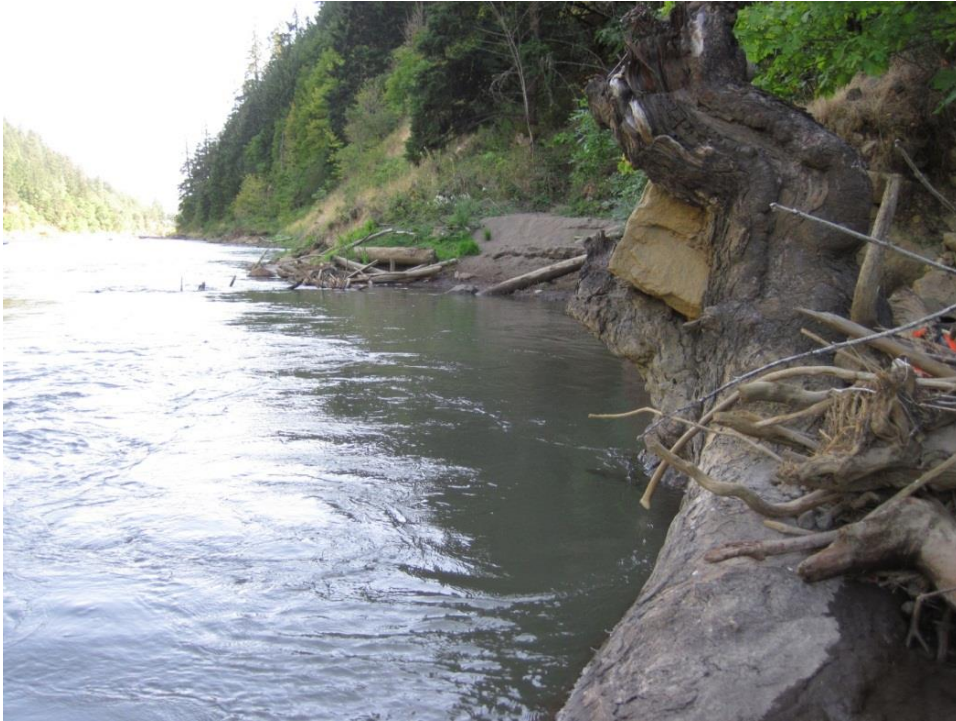
4,500 m downstream, river right, looking downstream towards right bank. Deposit of terrace is gray mass extending downstream from root wad (Aug 16, 2012 photograph)

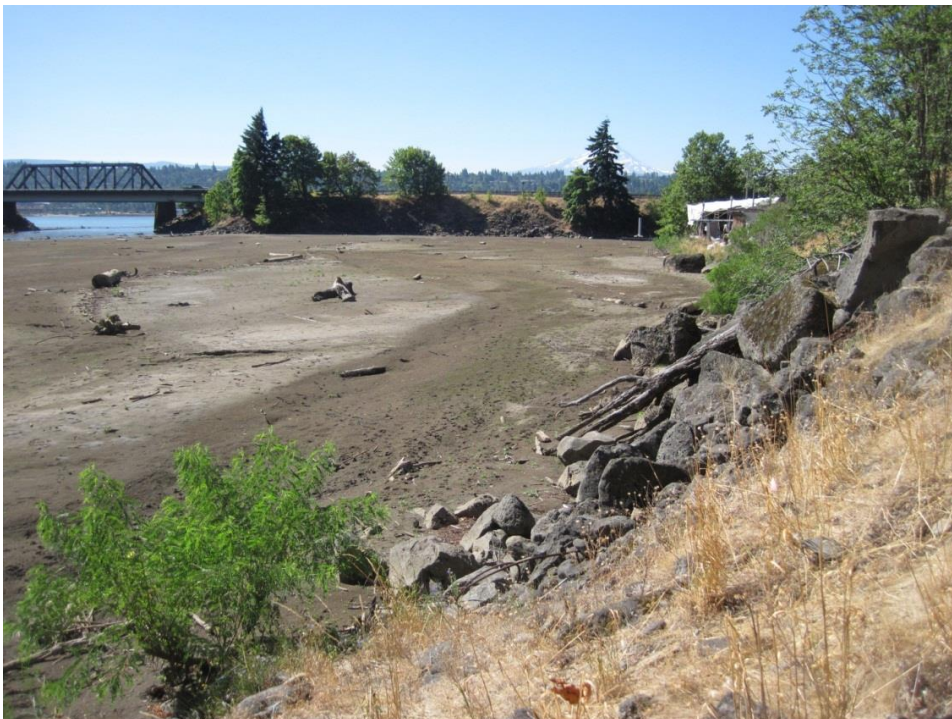
5,000 m downstream, river right, facing downstream towards river mouth and Columbia. Terrace indistinguishable from deposited sand bar (Aug 16, 2012 photograph).

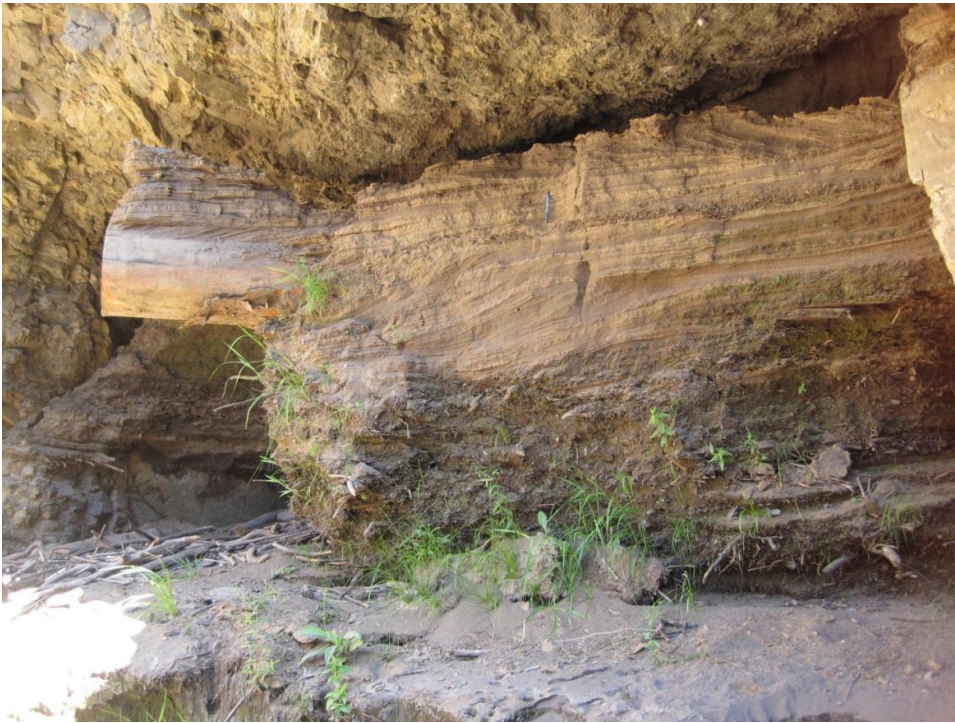
20 m downstream of dam, river right, looking towards bank

Photographs of low-angle cross-bedding within sand bed:
